Manhole Inspection Summary

Manhole # S13G1_016MH

Insp Date: **5/20/09 11:17 PM**

Location Address: **3212 W Patapsco Ave** Cross Street: **Washington Blvd**

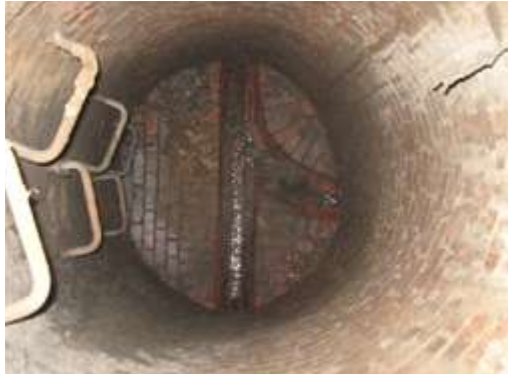
Defect 3

Steps Count: **6** Missing: **0** ☒ **Corroded**

Corroded Steps

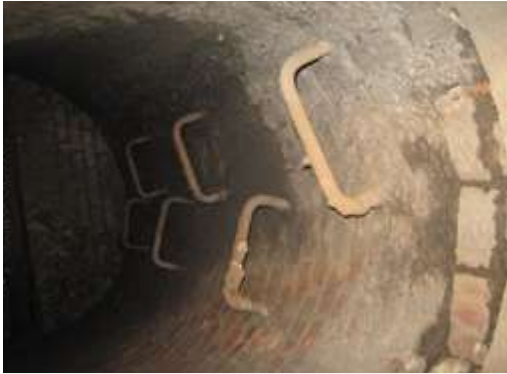
Defect 4

Infiltration: ☐ None ☐ Joint ☐ Cracks ☐ Mortar ☐ Roots ☒ **Wall**

infiltration corbel and barrel walls

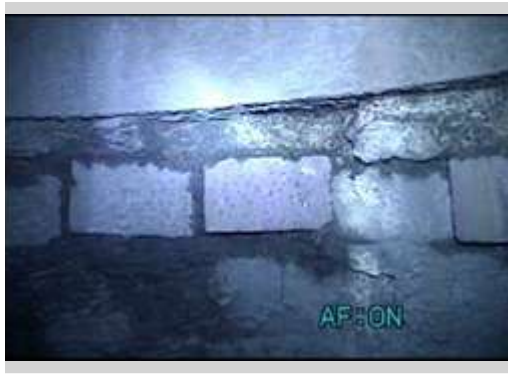
Defect 2

Infiltration: ☐ None ☒ **Joint** ☐ Cracks ☐ Mortar ☐ Roots ☐ Wall

infiltration at the chimney frame joint

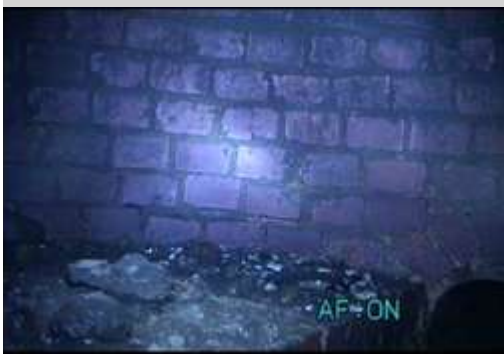
Defect 1

Condition: ☐ Sound ☐ Cracked ☐ Root Intrusion ☐ Deteriorated ☐ Leaks ☒ **Debris**

debris on bench
